Manhole Inspection Summary

Manhole # S37KK_022MH

Insp Date: **3/19/07 8:44 AM**

Location Address: **427 LAFEYETTE AVE**

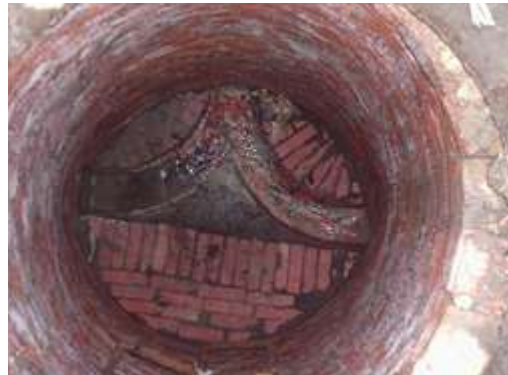
Top View

Corroded and missing steps. Evidence of surcharge - Bench debris. Channel debris.

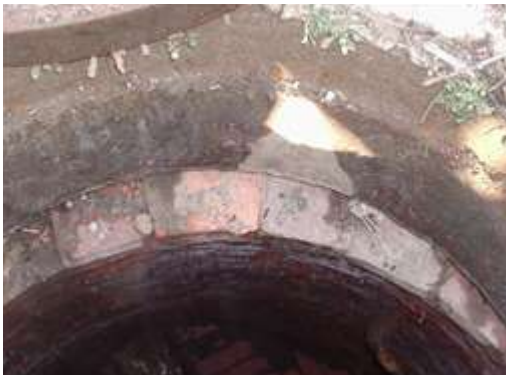
Defect

Frame leaks. Frame offset. Adjustment deterioration and infiltration.

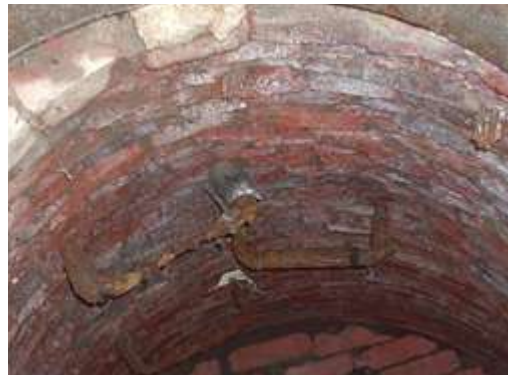
Defect

Adjustment, Corbel and Barrel infiltration.

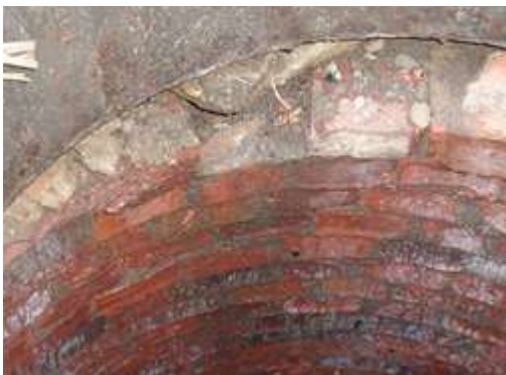
Defect

Frame leaks. Adjustment deterioration and infiltration. Corbel infiltration.

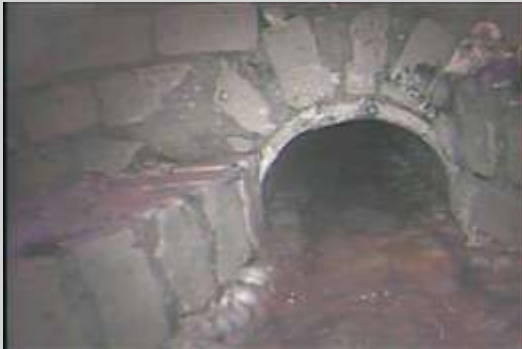
8 in. Circular Gravity Sewer Pipe Out @ 12 O'Clock

Deposits: ☐ None ☐ **Mud** ☐ Sludge ☐ **Debris** ☒ **Grease**

Silt Depth: **0** (in.) Deposits Extent: **Light**

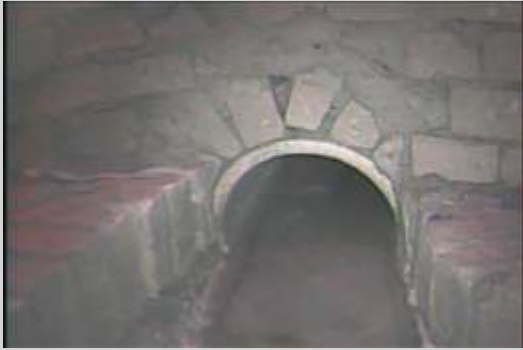
Pipe In @ 9 O'Clock

Channel deterioration.

Deposits: ☐ None ☒ **Mud** ☐ Sludge ☒ **Debris** ☐ Grease
